Earthquake Insights Seminar: Unveiling Discoveries and Preparedness Strategies

Lessons Learned from the M7.8 Türkiye Earthquake of 6 February 2023

October 13, 2023

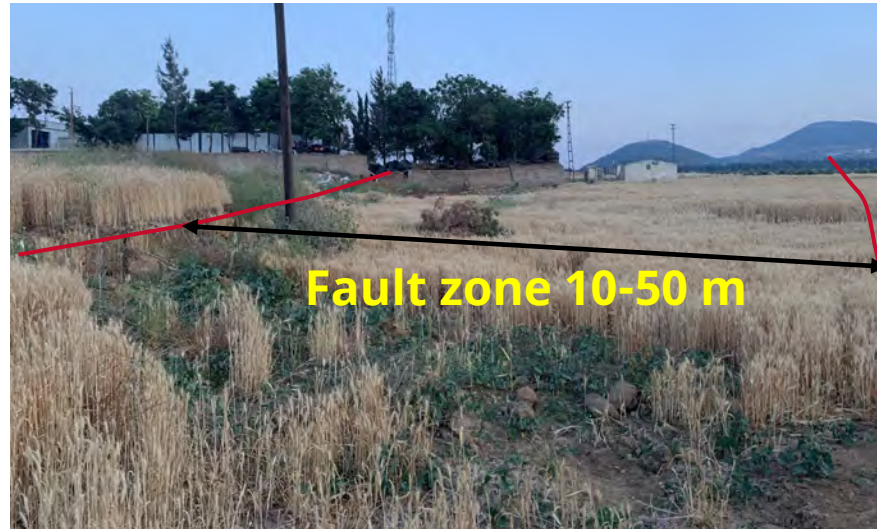
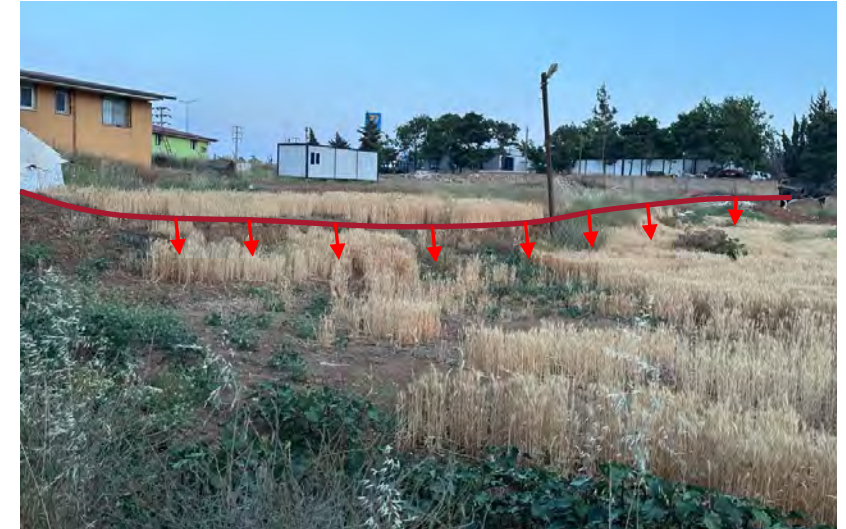
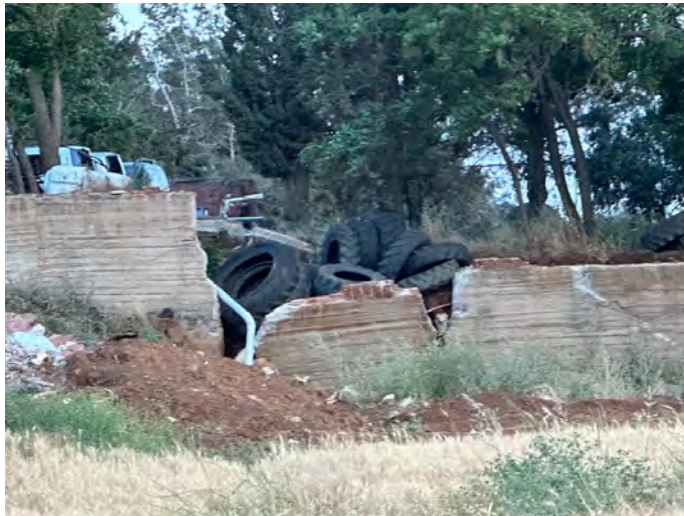
Surface Rupture in Islahiye

The fault zone becomes 10-50 m in width in a N30°E direction

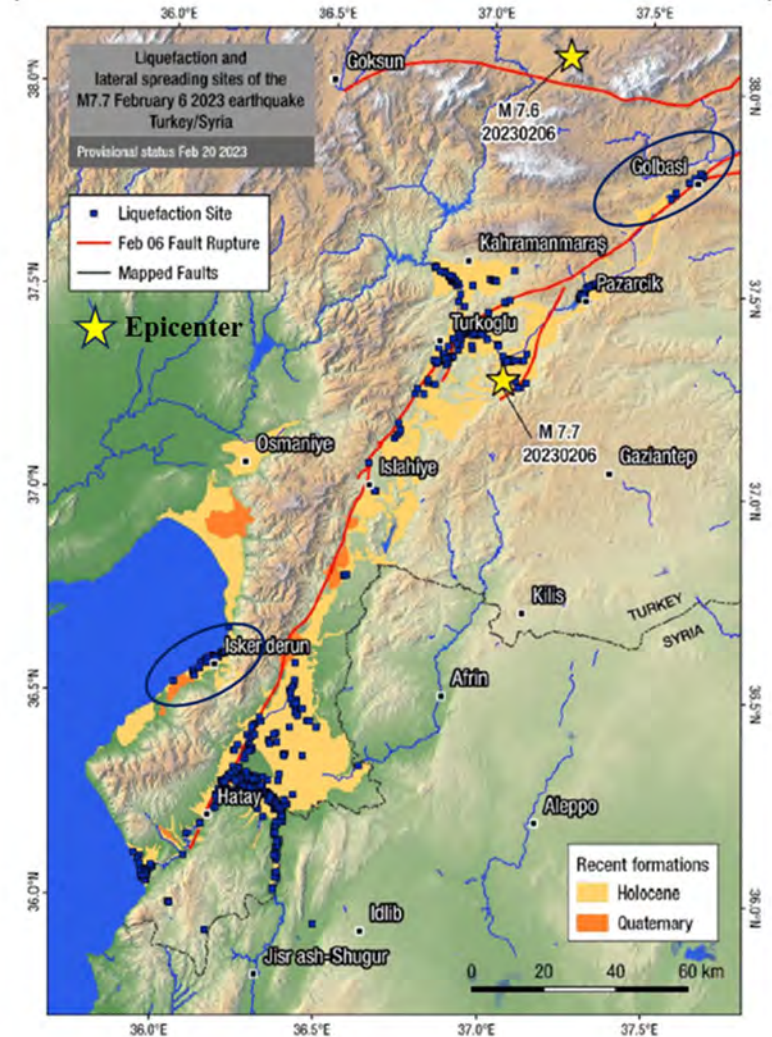
Golbasi

- City built up after the 1950s on a former wetland
- Compressible wetland sediments up to 21 m thick
- Liquefaction induced ground failures were widespread in several cities

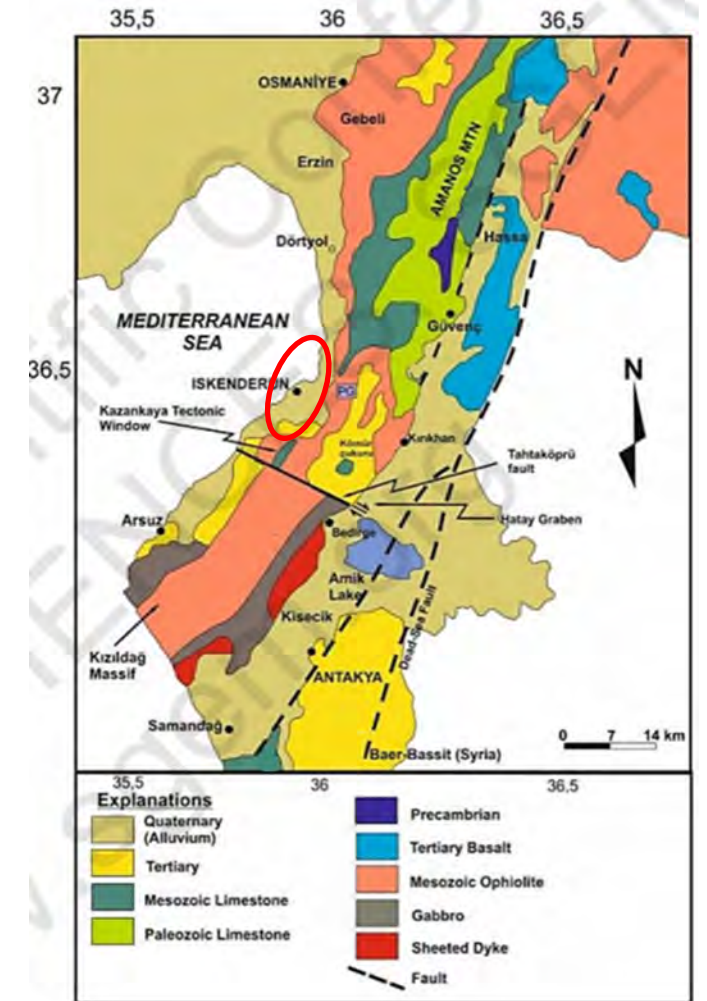
Iskenderun

- Young marine deposits and fills dominate the coastal plains.
- Soils along the coastal area include loose to medium dense sands and silty sands.
- Soil conditions are highly variable because of the marine and alluvial depositional environment, as well as the reclamation fill.
- Severely damaged due to widespread lateral spreading and liquefaction along its coastal front.

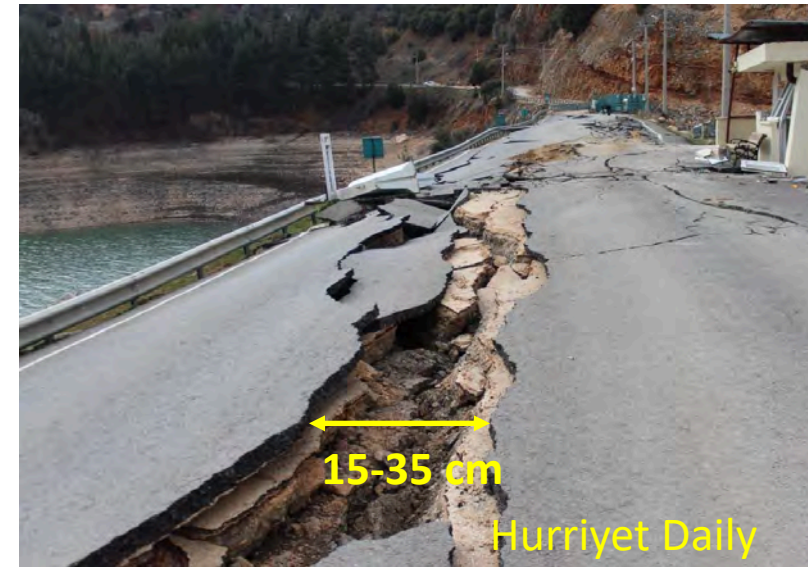
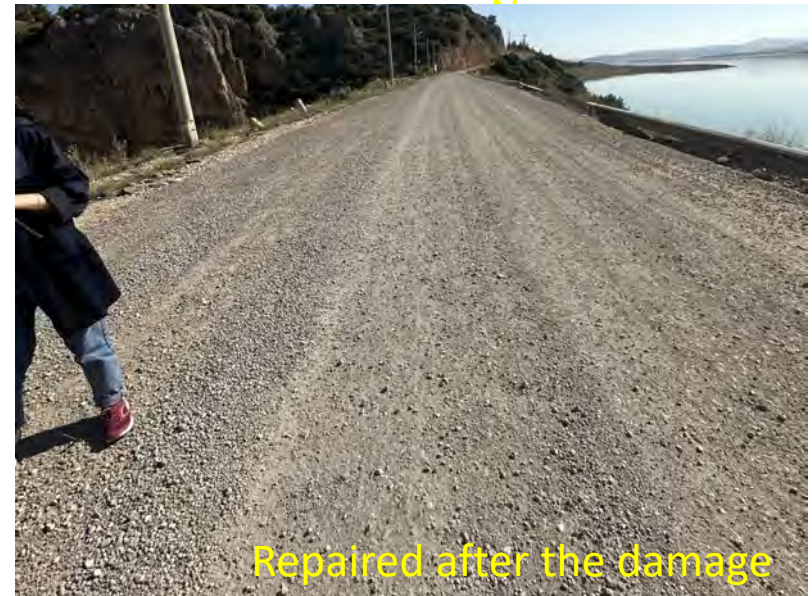
Kartalkaya dam

- A clay core earthfill dam constructed in 1972 in Kahramanmaraş
- Crest height from the stream level is 56 meters and store 1.45 million m³ water.
- Dam is 3 km away from the epicenter of the first event.
- Moderate damage with crack widths varying in between 15-35 cm was observed along the crest of the dam

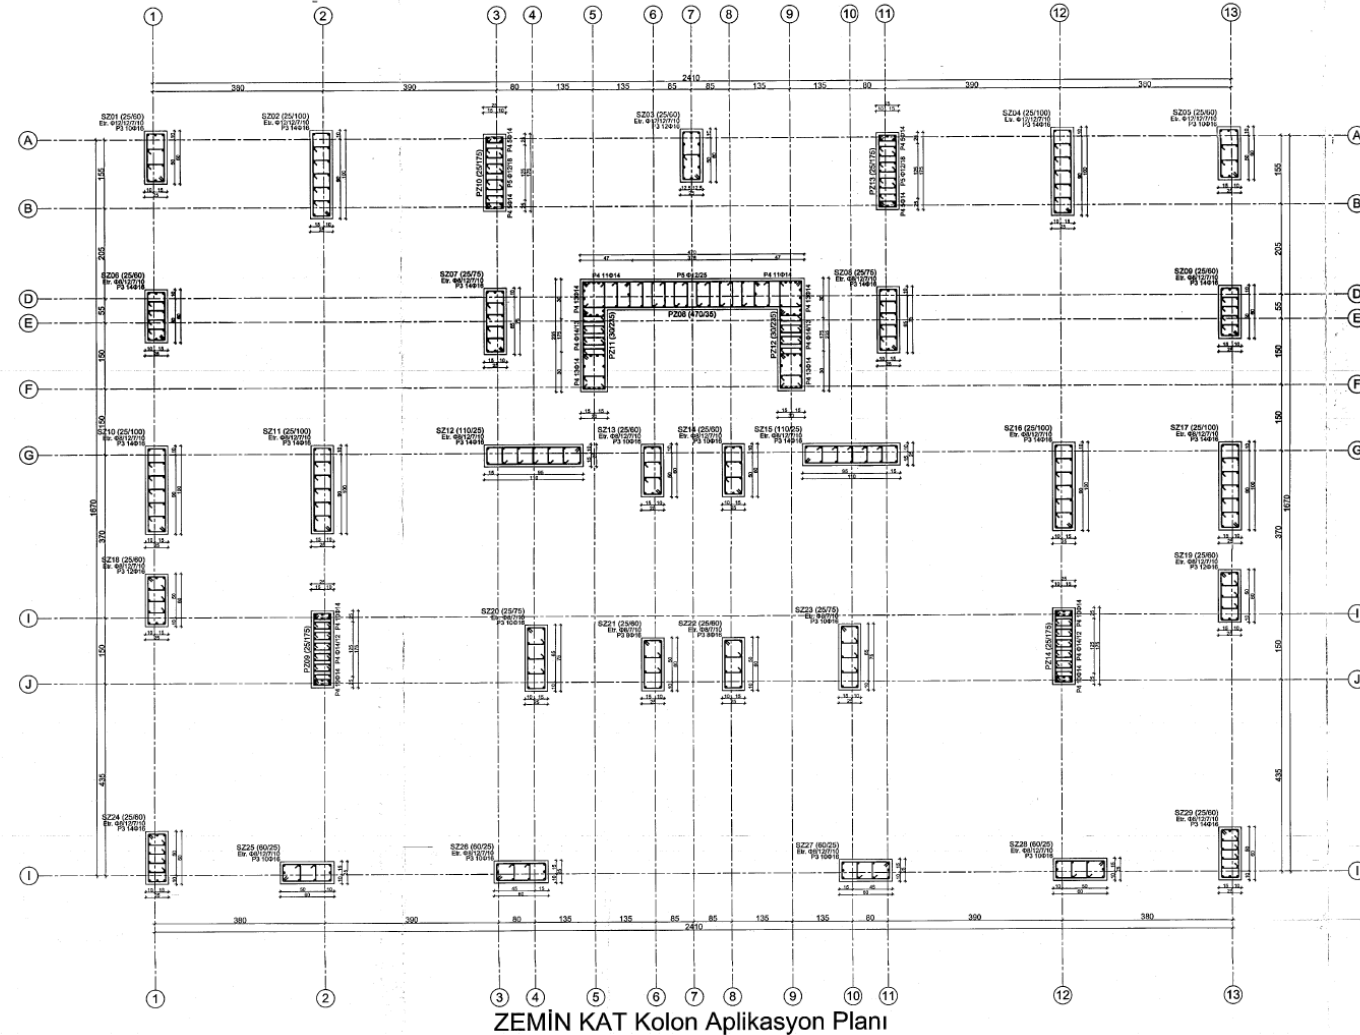
EXCESSIVE MOMENT FRAME FLEXIBILITY - COLUMN LAYOUT

- Majority of the columns were aligned in the N-S direction
- Very few columns aligned in E-W direction
- **Column layout inadequate for resisting lateral seismic forces in both directions**

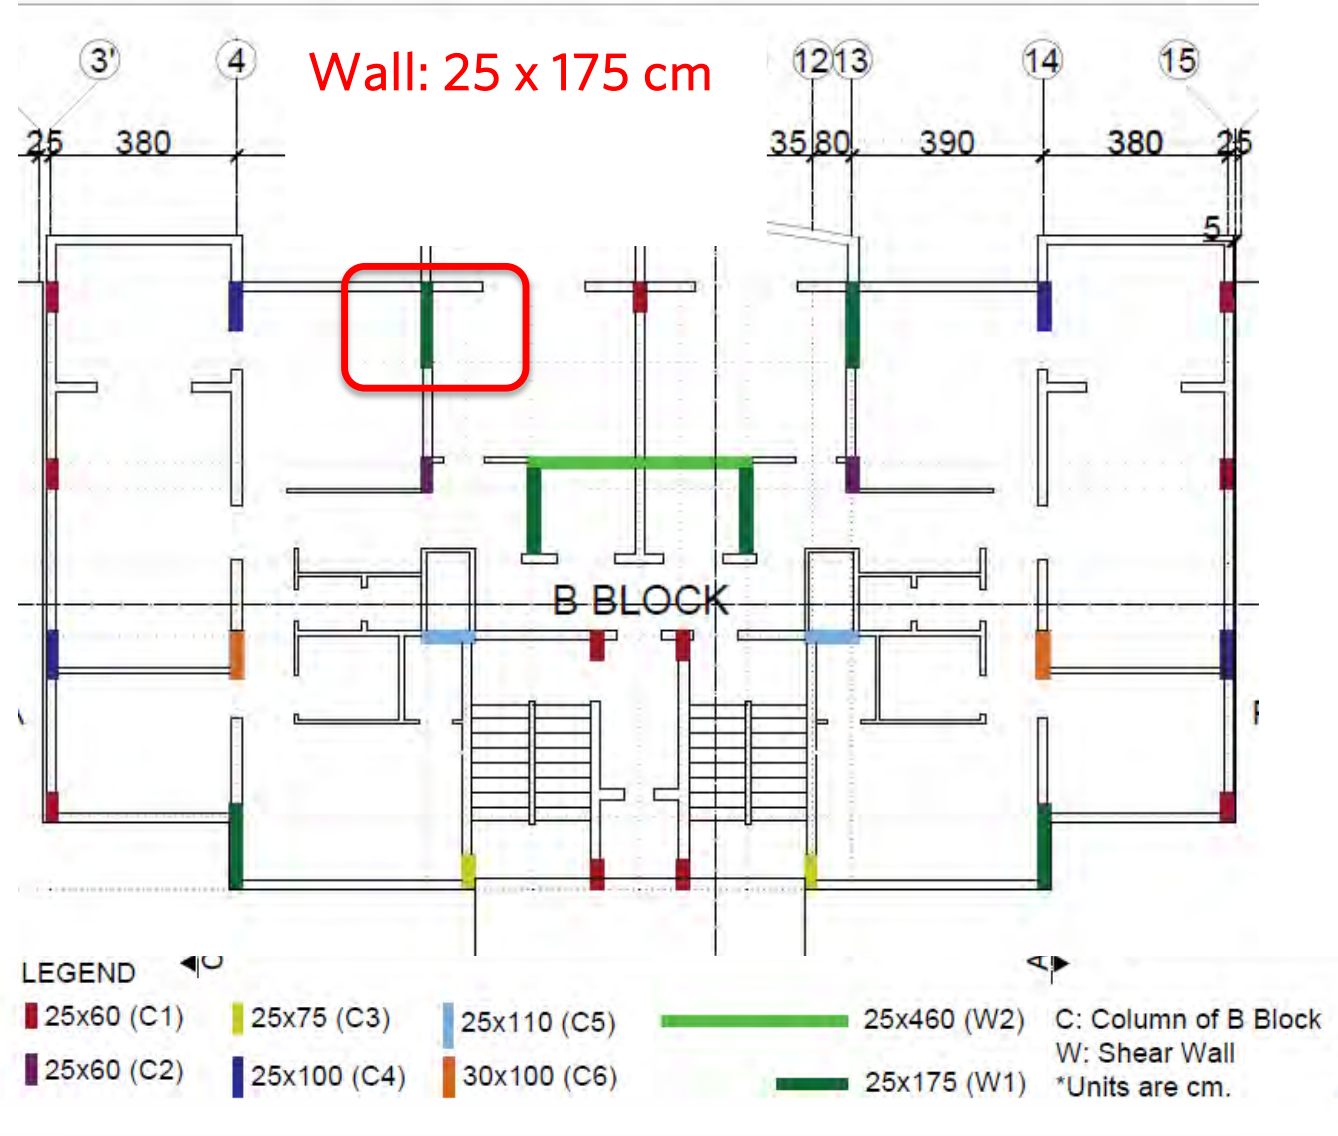
EXCESSIVE MOMENT FRAME FLEXIBILITY - INADEQUATE SHEAR WALLS

- Many tall RC buildings with moment frames have only a few shear walls.
- In some buildings, an elevator core is the only vertical element that acts like a shear wall.
- Typical columns have an oblique (rectangular) shape, with 25 cm width and depth ranging from 60-100 cm.
- When present, shear walls are relatively short (length less than 2 meters).
- **Min required length/thickness ratio for RC shear walls = 7.0 (2007 code).**

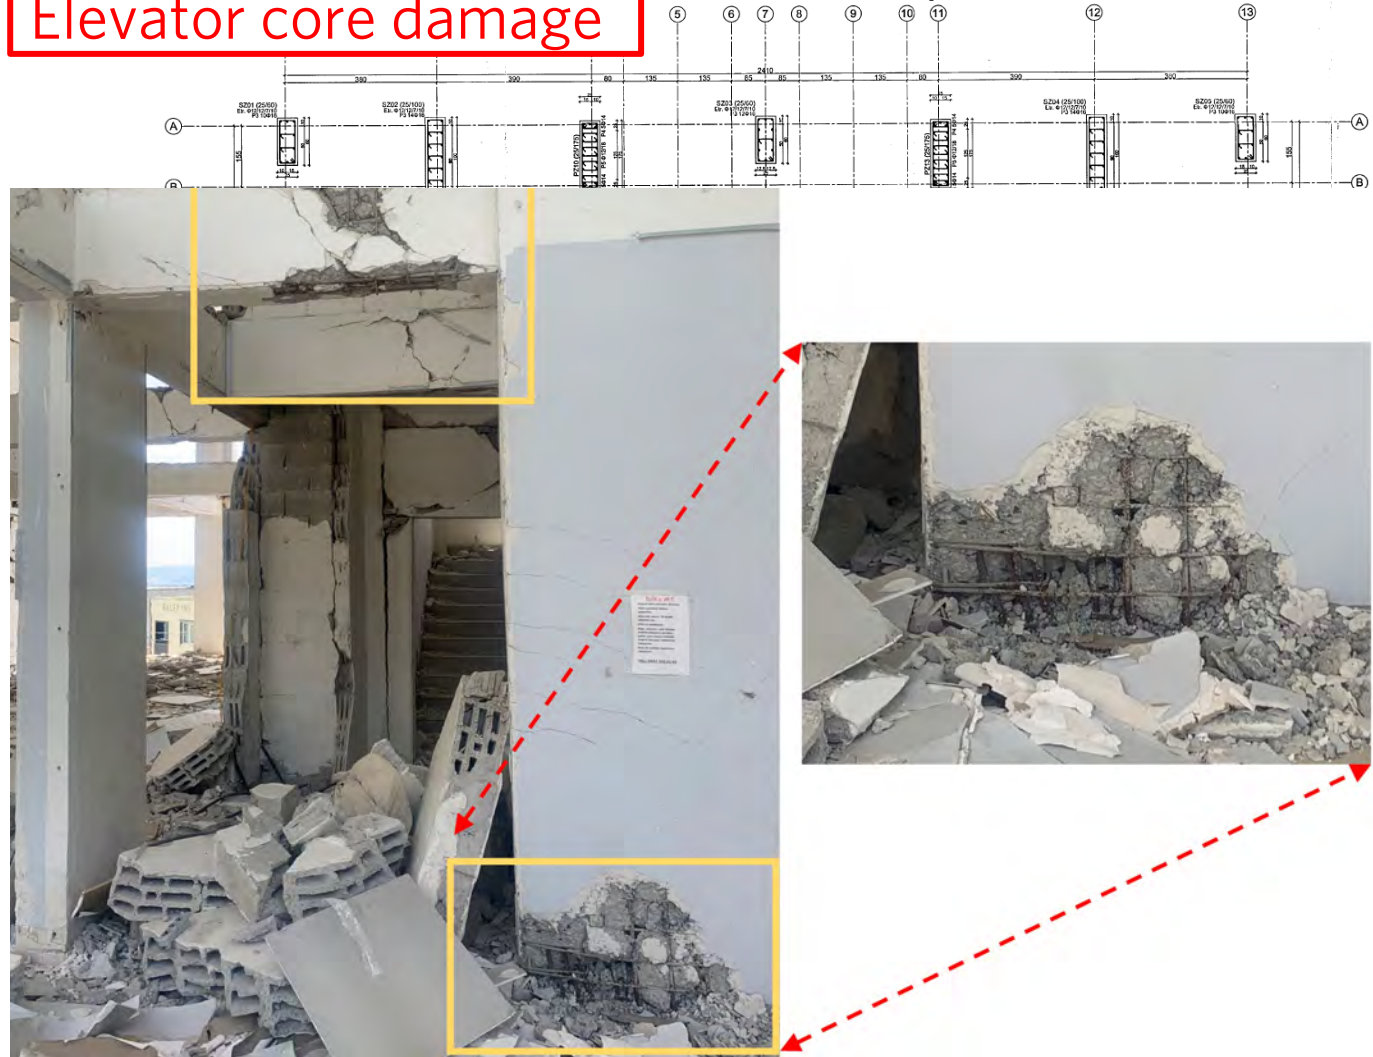
Elevator core damage

- Some of these buildings experienced structural damage due to inadequate lateral load-resisting capacity (as expected due to inadequate amount of walls)
- In many cases the extent of structural damage was minor to moderate
- Main structural elements: columns, beams, walls (e.g. elevator core)

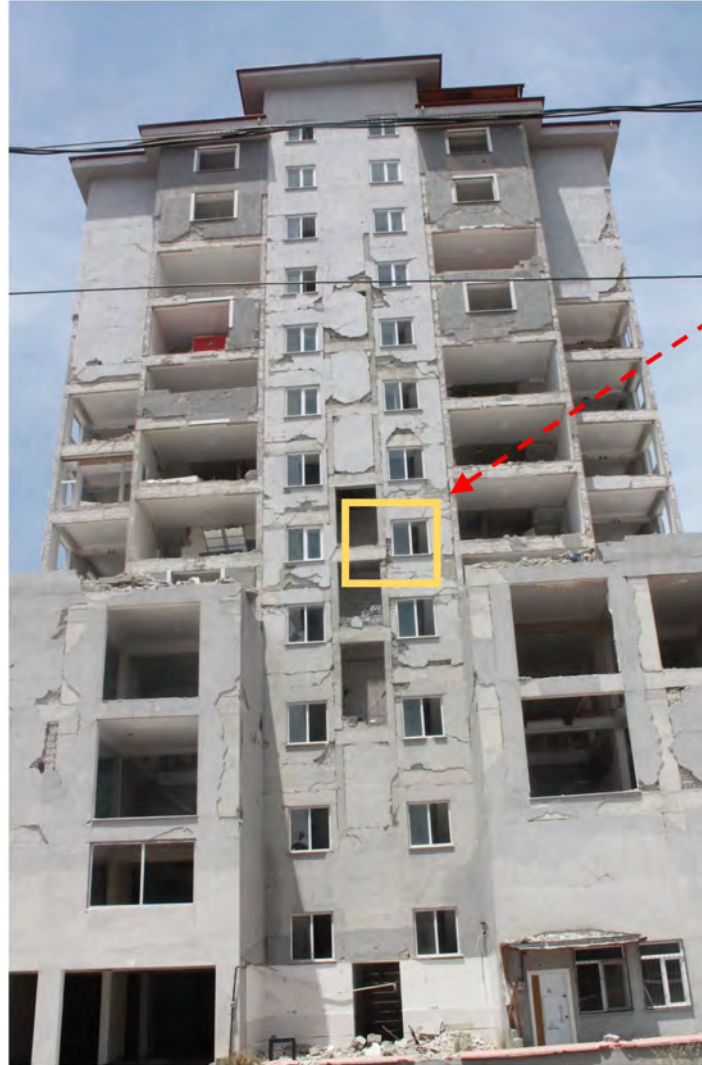
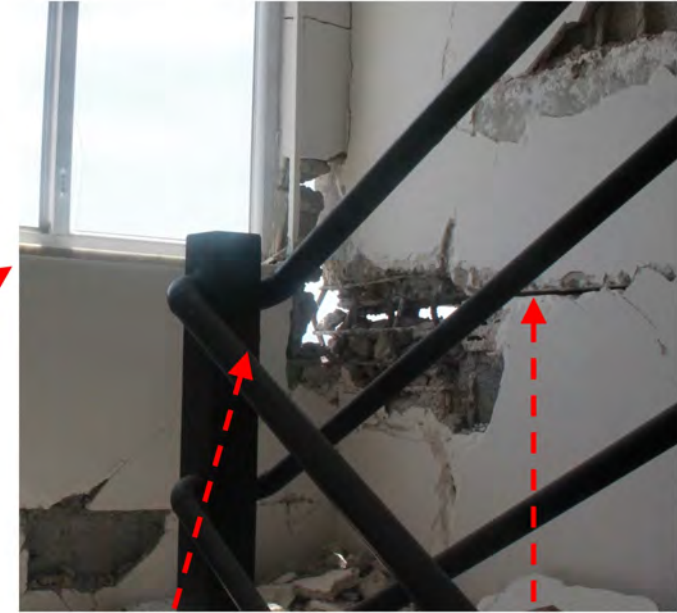
Column damage

- It is true that columns and beams were subjected to high seismic demand, but in many cases detailing of reinforcement was deficient
- **Cross-ties missing from the constructed columns (although prescribed by the designers)!**

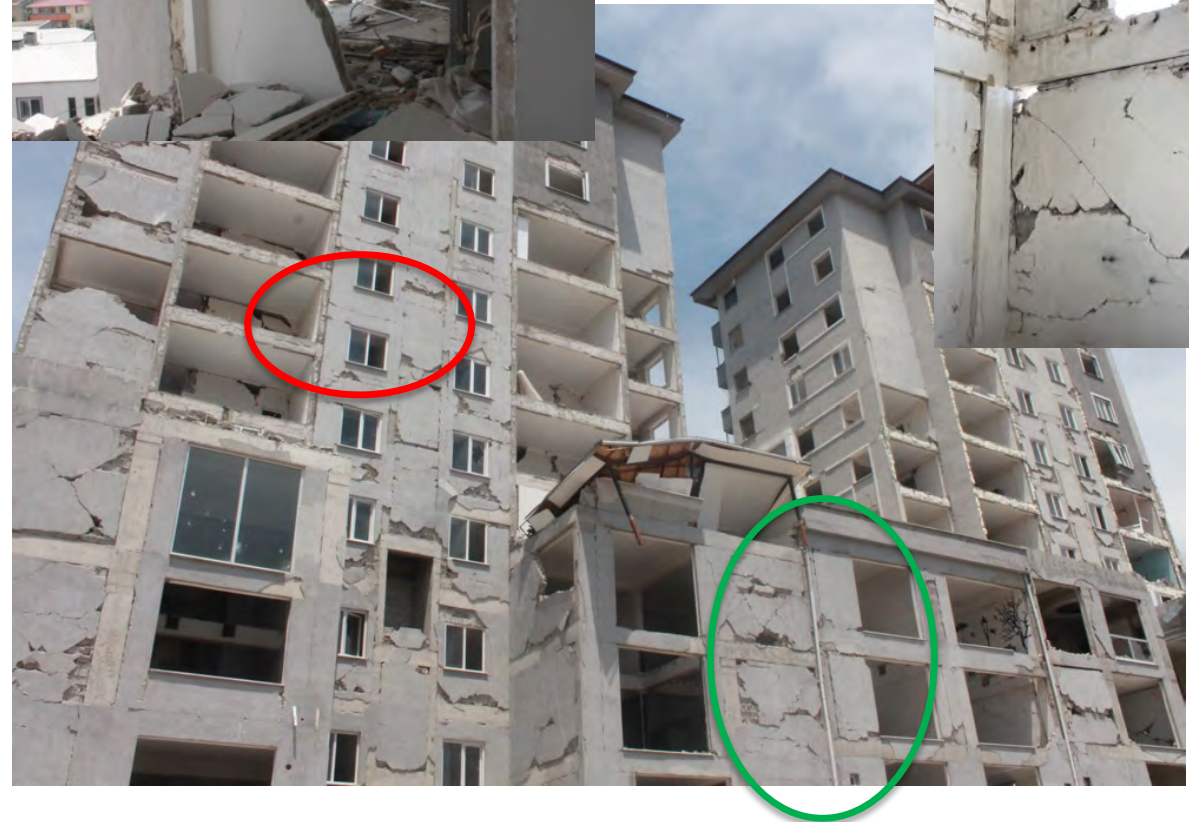
Exterior infills (interior view)

- Extensive non-structural damage observed - particularly in masonry infills and partitions
- Damage observed both in exterior and interior infills/partitions
- Non-structural damage can be attributed to significant lateral displacements (drift) - due to excessive flexibility

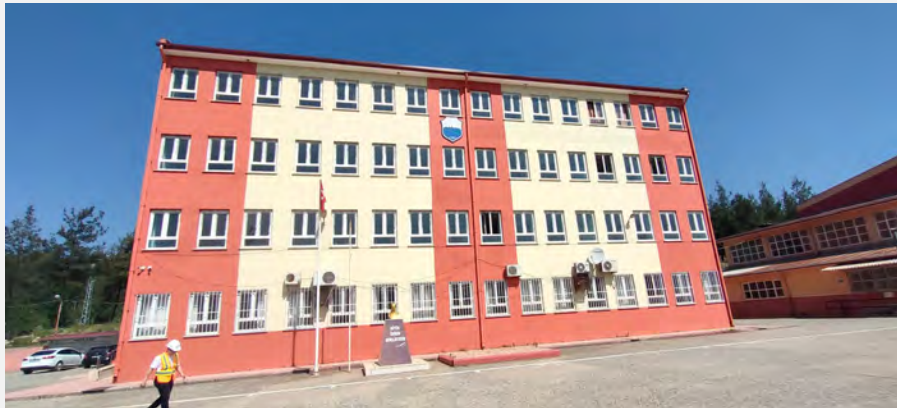
5. Bache (Osmaniye)

No significant damage

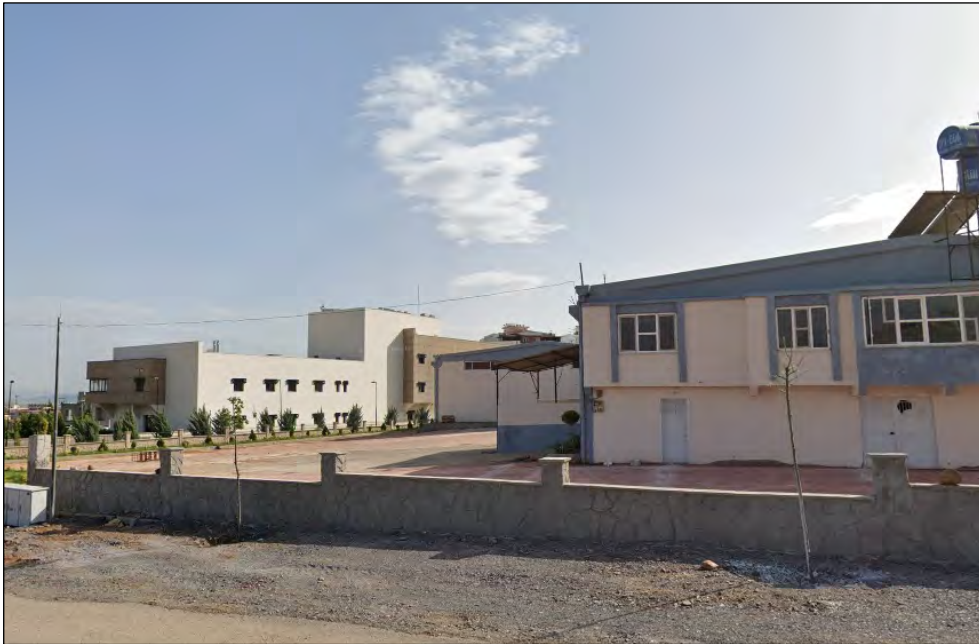
- Nurdagi population of 41,000
- Built in 2003, upgraded in 2015
- Hospital was out of service; significant non-structural damage.
