Earthquake Insights Seminar: Unveiling Discoveries and Preparedness Strategies

Lessons Learned from the M7.8 Türkiye Earthquake of 6 February 2023

October 13, 2023

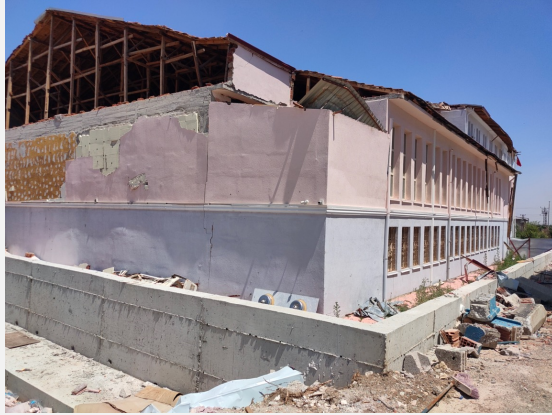
Damage to
Roof truss
