Earthquake Insights Seminar: Unveiling Discoveries and Preparedness Strategies

Lessons Learned from the M7.8 Türkiye Earthquake of 6 February 2023

October 13, 2023

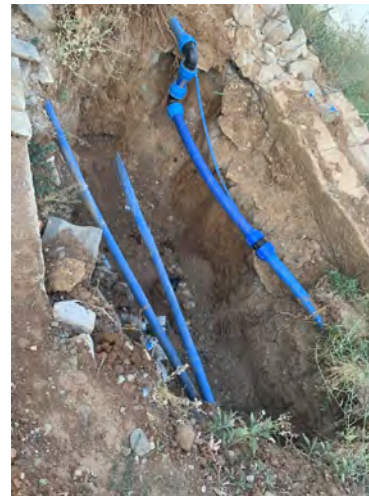
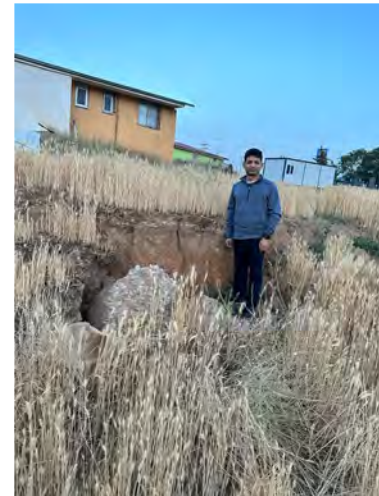
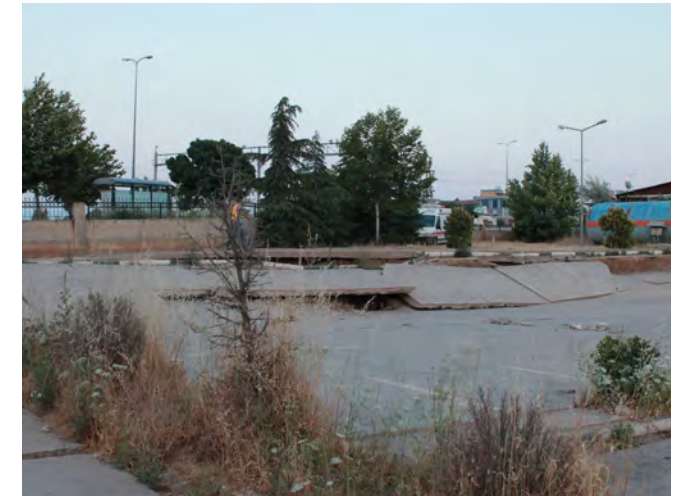
Surface Rupture in Islahiye

The fault zone becomes 10-50 m in width in a N30°E direction

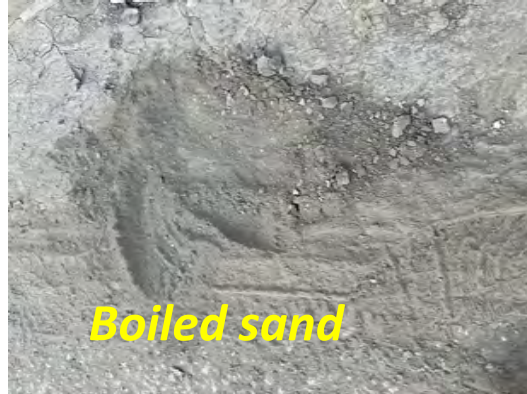
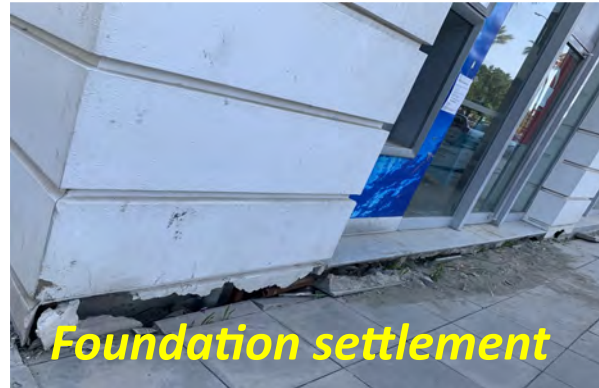
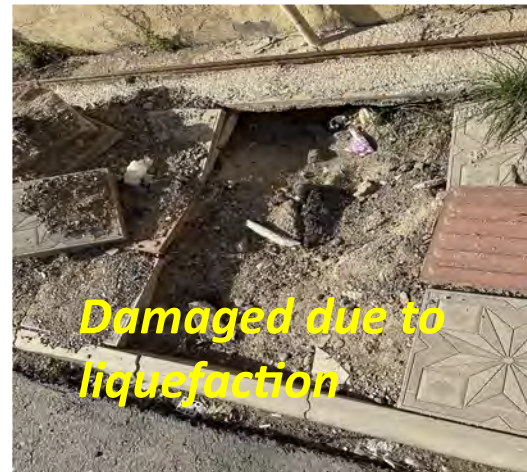
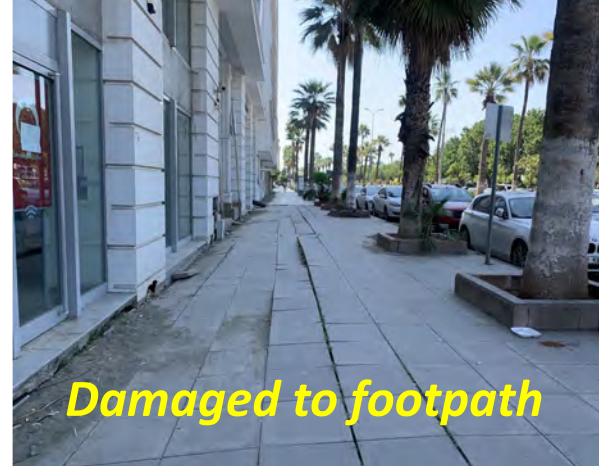
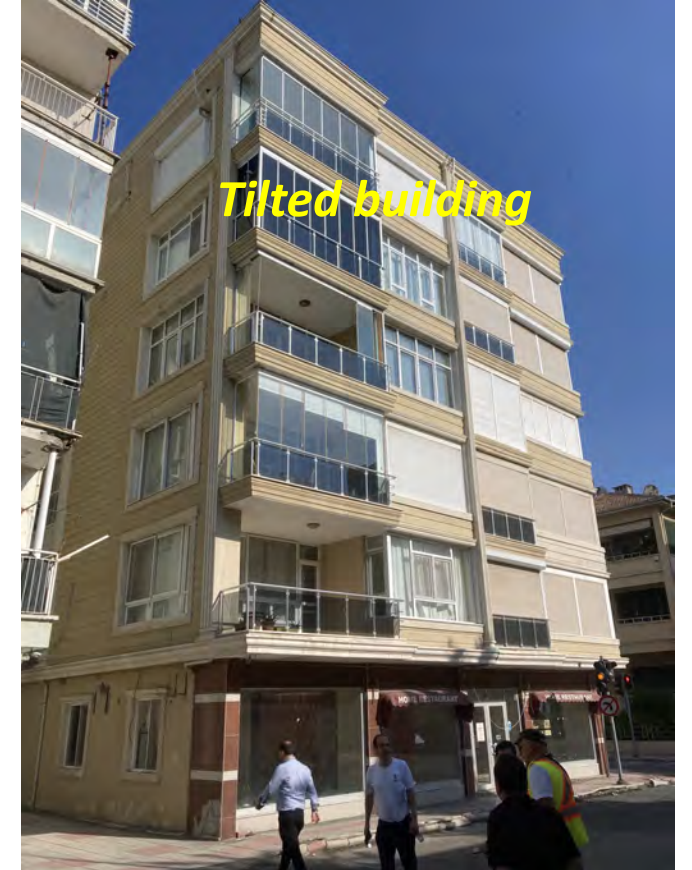
Iskenderun

- Young marine deposits and fills dominate the coastal plains.
- Soils along the coastal area include loose to medium dense sands and silty sands.
- Soil conditions are highly variable because of the marine and alluvial depositional environment, as well as the reclamation fill.
- Severely damaged due to widespread lateral spreading and liquefaction along its coastal front.

Land reclamation using liquefiable material is problematic.

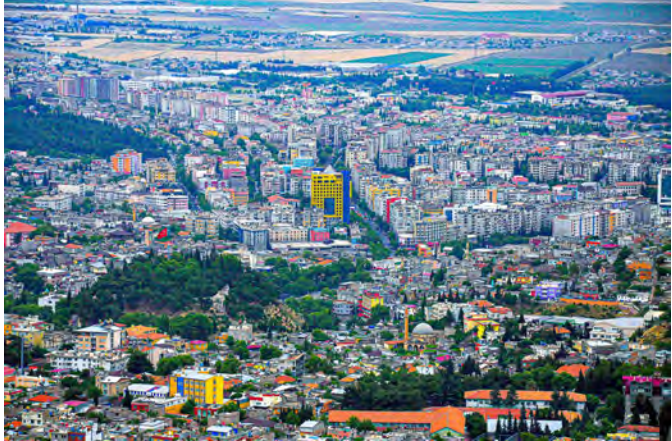
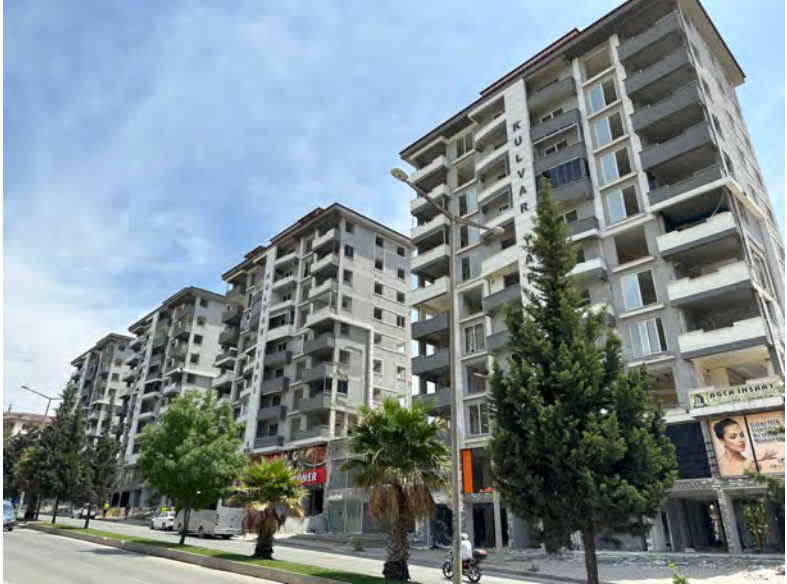
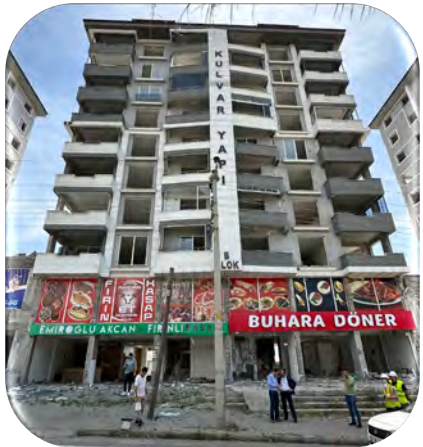
EXCESSIVE MOMENT FRAME FLEXIBILITY - AN EXAMPLE OF A BUILDING COMPLEX IN KAHRAMANMARAŞ

Excessive flexibility of the SFRS in taller RC buildings is mostly due to inadequate amount of shear walls!

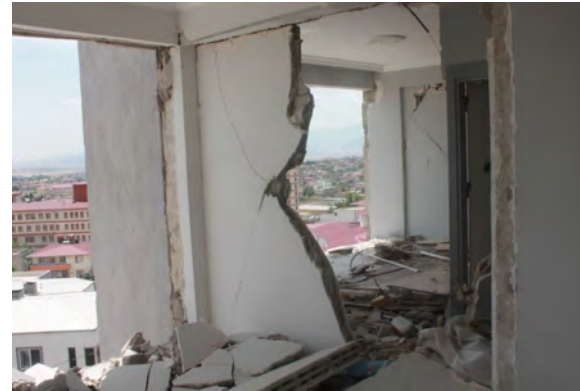
Exterior infills (interior view)

- Extensive non-structural damage observed - particularly in masonry infills and partitions
- Damage observed both in exterior and interior infills/partitions
- Non-structural damage can be attributed to significant lateral displacements (drift) - due to excessive flexibility

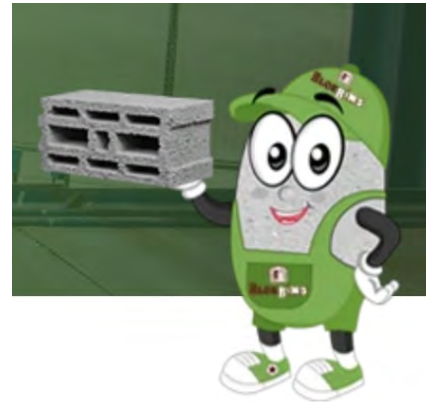
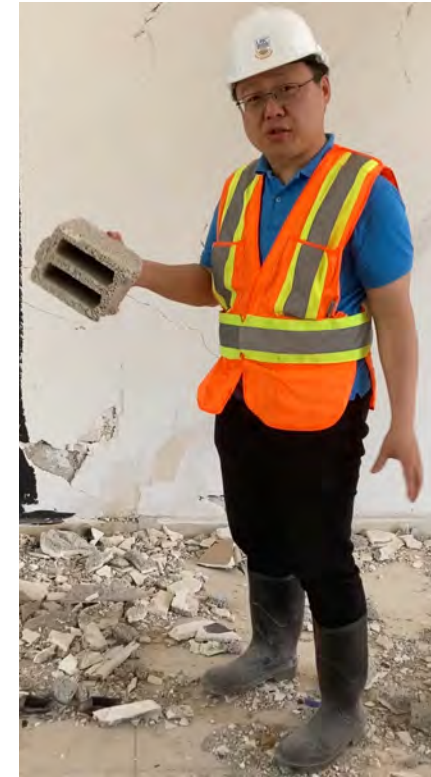
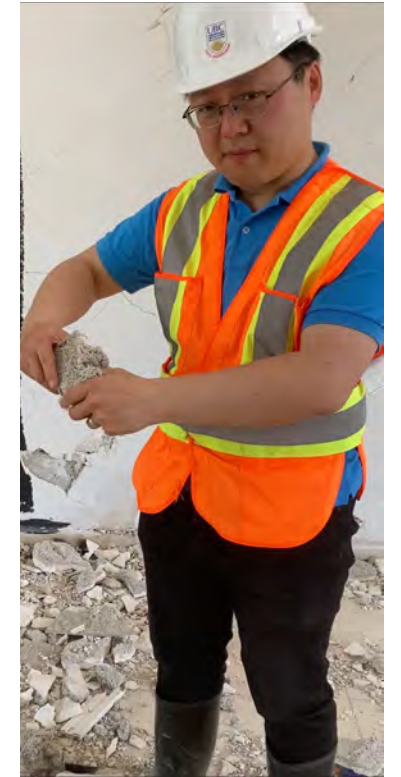
- Another cause of damage for nonstructural elements – poor quality of masonry materials used for infill construction
- Hollow concrete blocks – made of low-strength material, known as bimsblock or briket in Turkish – similar to AAC blocks in North America (Aerated Autoclaved Blocks)
- Wall thickness ranges from 100 to 190mm

Compressive strength – only 1.7 MPa!

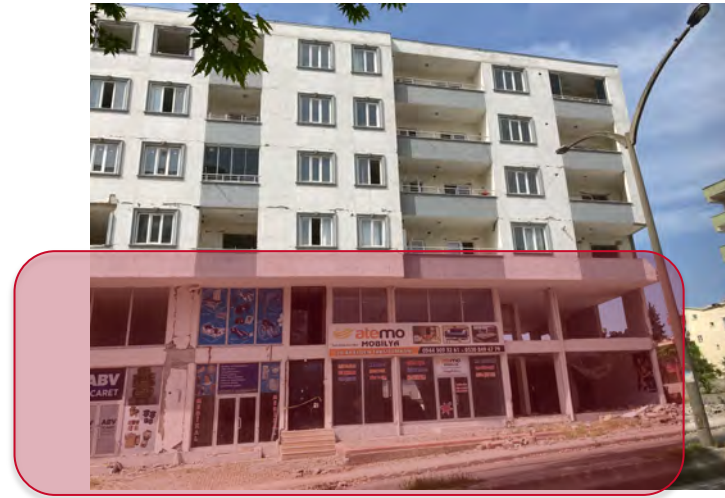
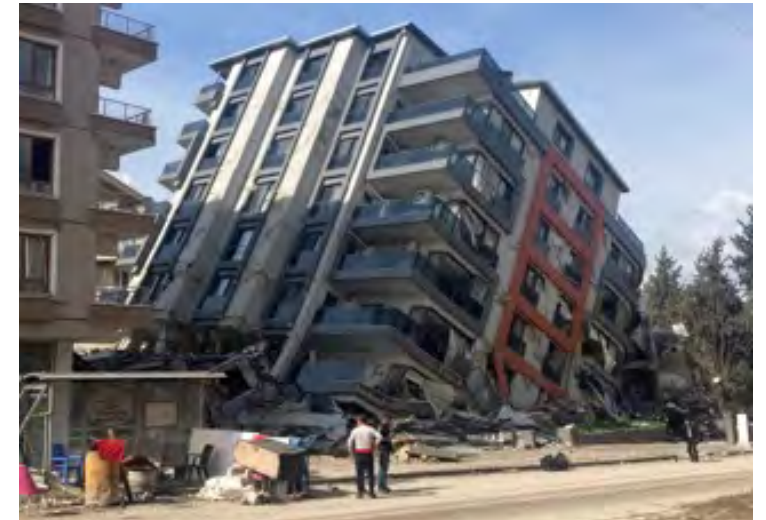
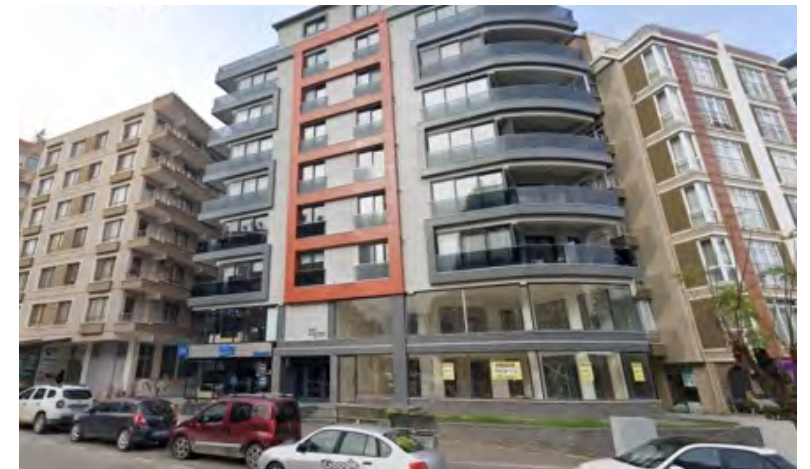
WEAK STOREY (AKA "SOFT STOREY")

Many buildings in urban areas have mixed function, with the bottom floor intended for commercial use - leading to a "Soft storey" collapse mechanism

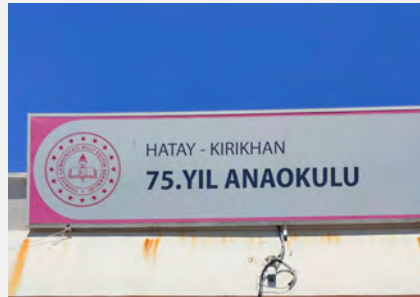
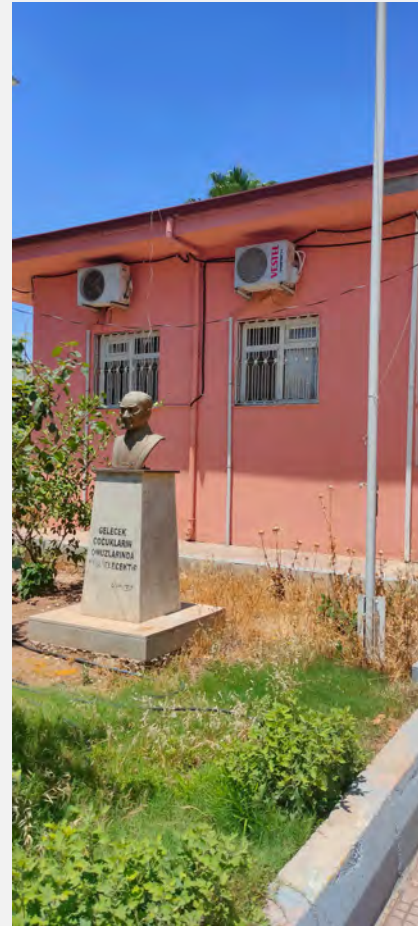
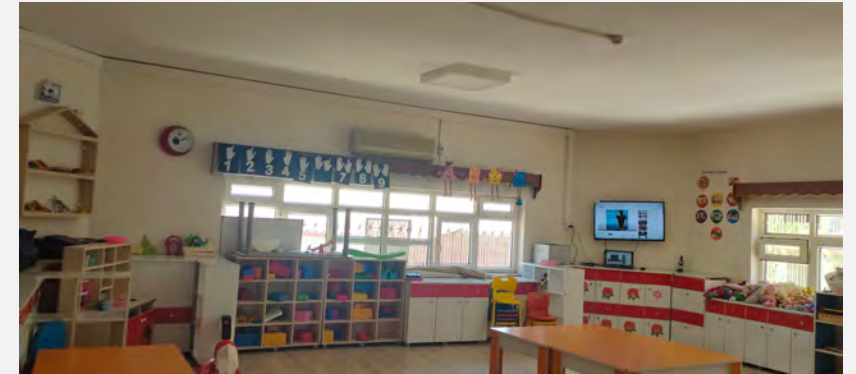
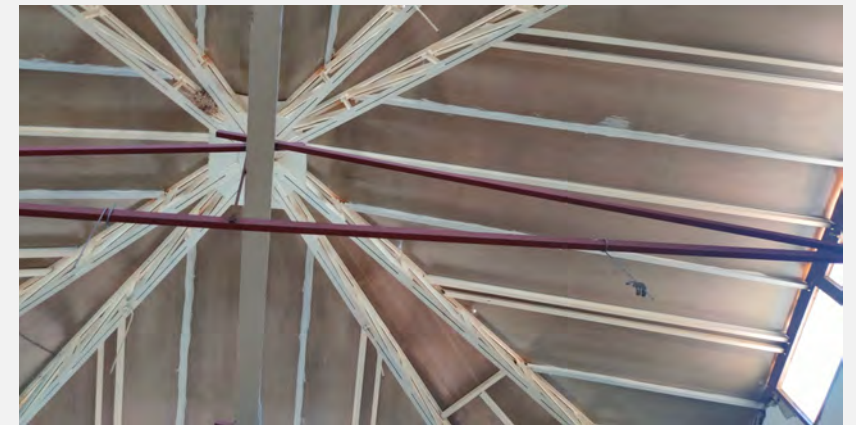
3. Kirikhan (Kindergarten)

Fall of ceiling in the main lobby of kindergarten

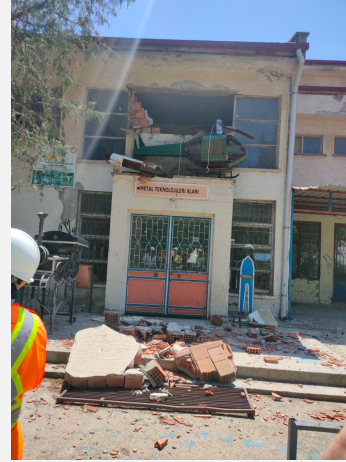
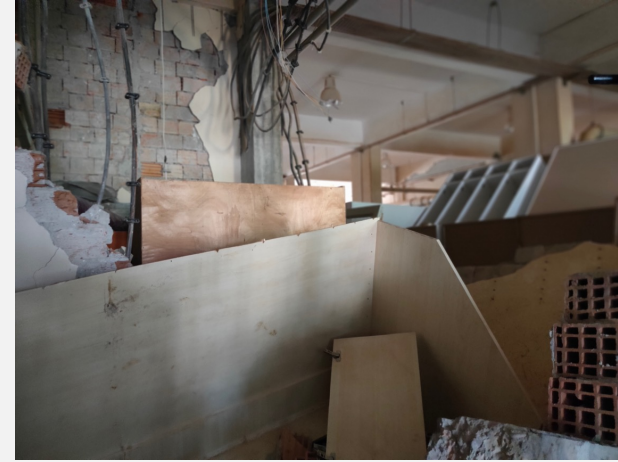
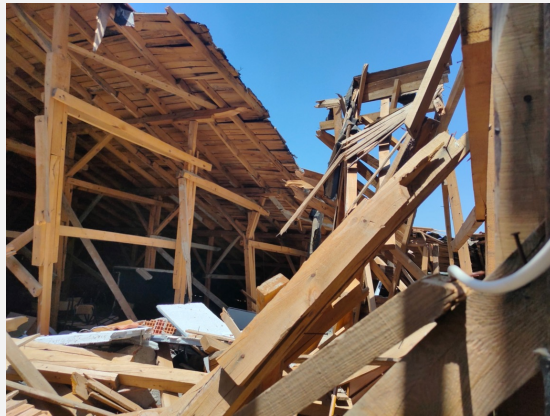
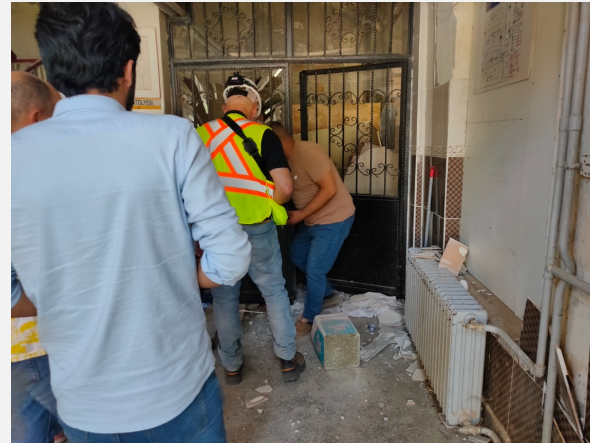
Significant
non-structural
damage in lab

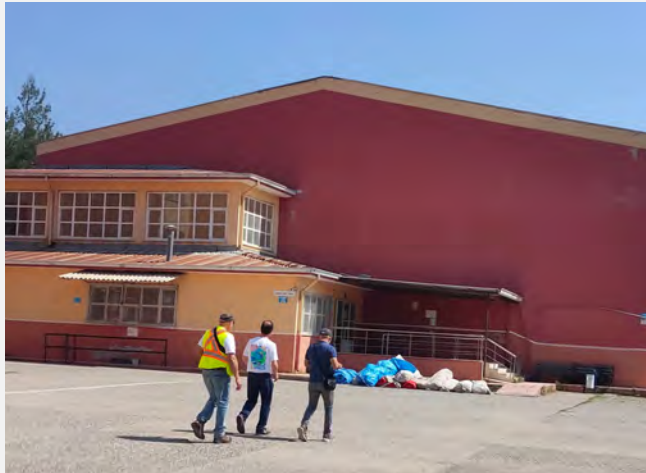
5. Bache (Osmaniye)

No significant damage

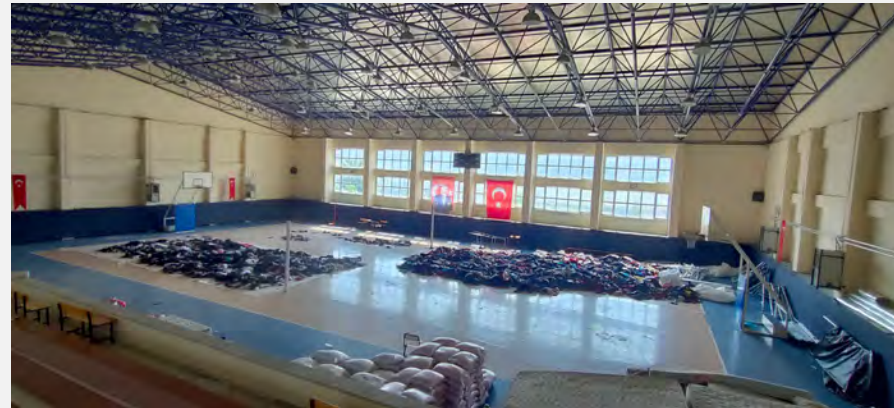
Gym used for temporary shelter

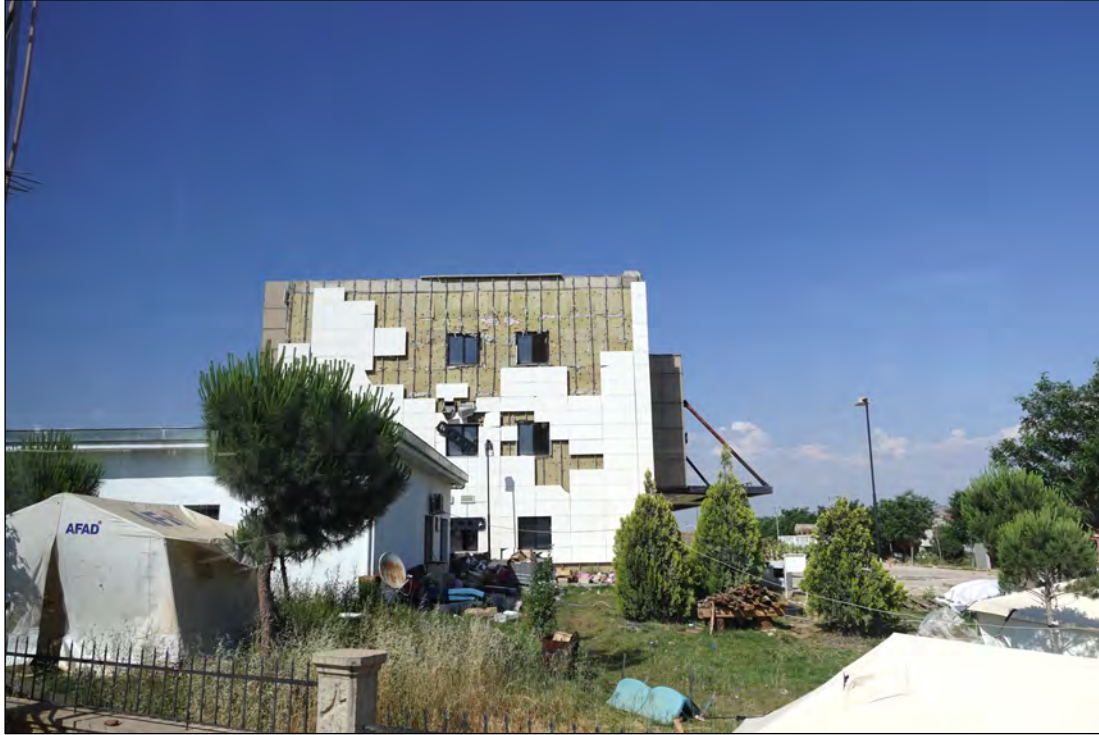
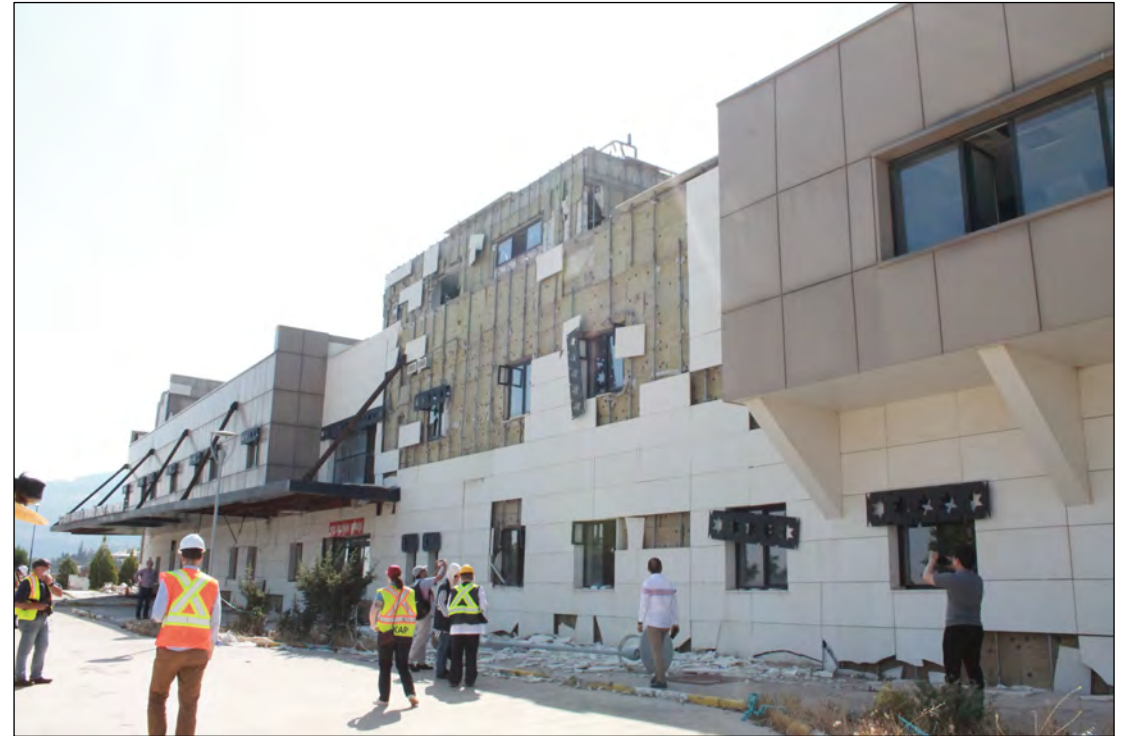
Fixed-Base Hospital: Nurdagi

- Nurdagi population of 41,000
- Built in 2003, upgraded in 2015
- Hospital was out of service; significant non-structural damage.

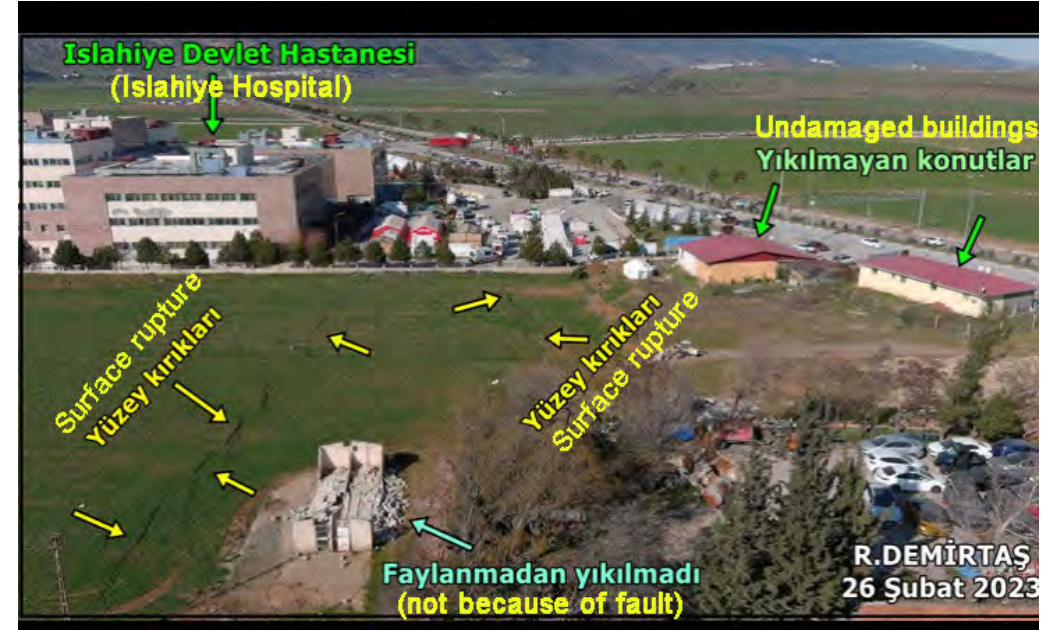
Fixed-Base Hospital: Islahiye

- Islahiye population of 67,650
- Hospital is located roughly 100 m from the fault line
- Hospital remained operational after the earthquake

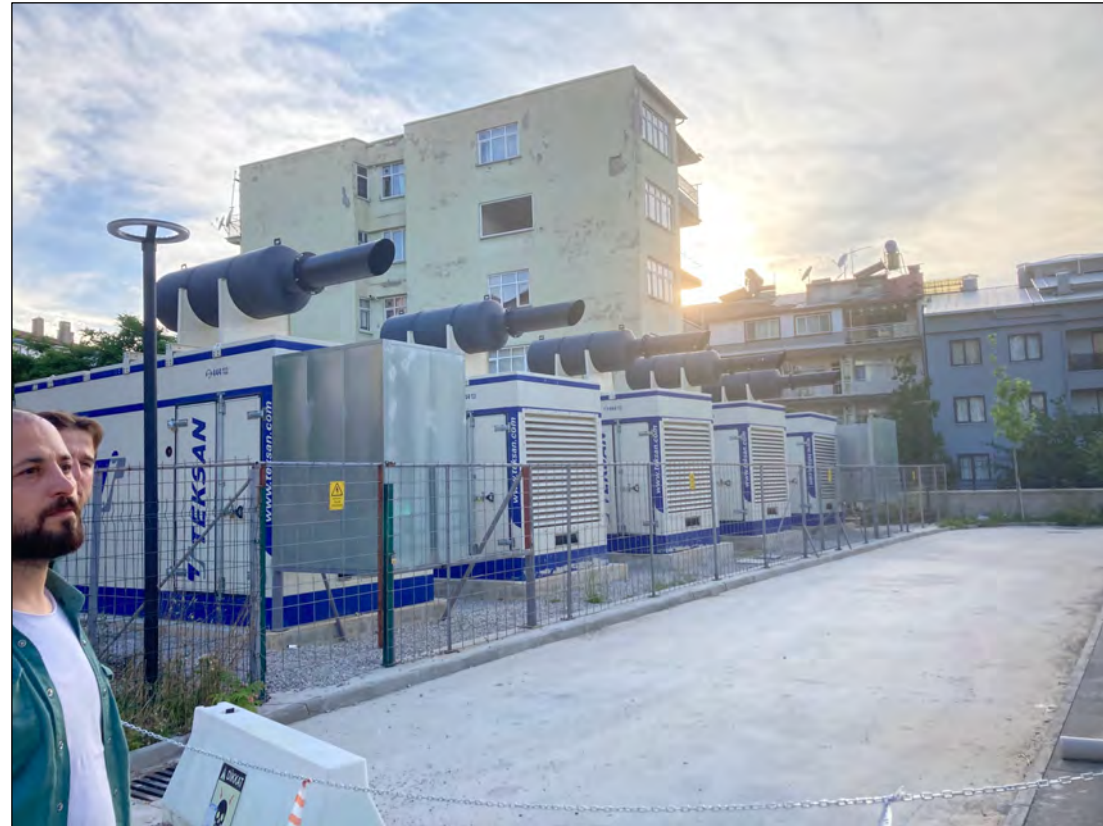
Base-Isolated Hospital: Malatya

Hospital has 5 back-up generators and additional purifying systems

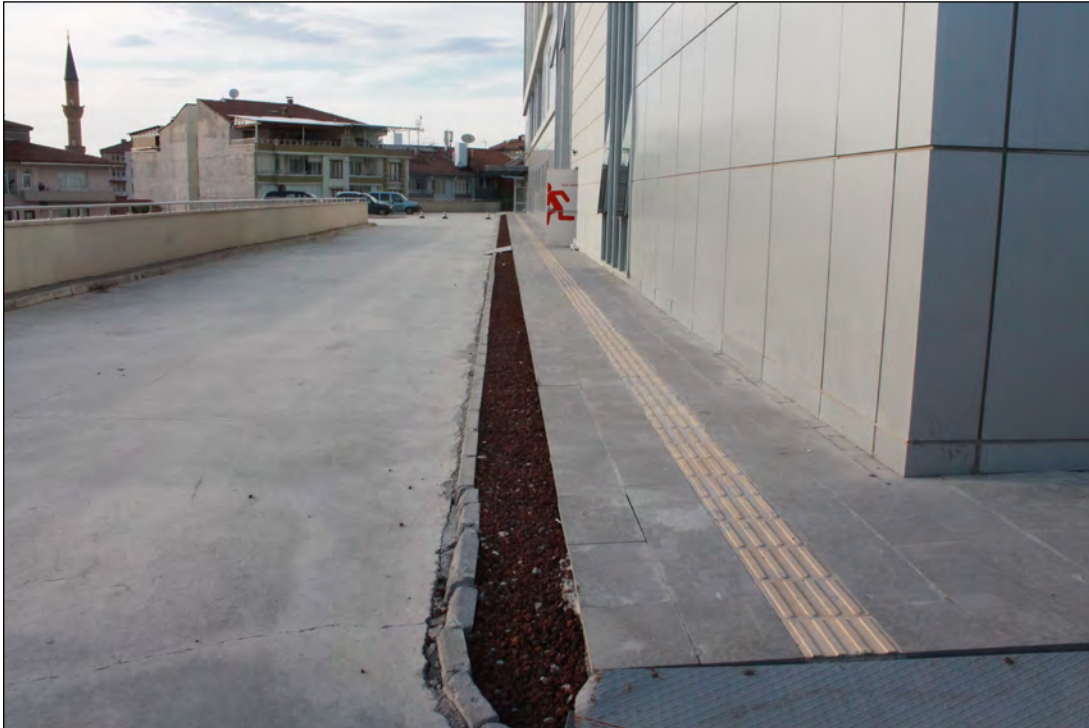
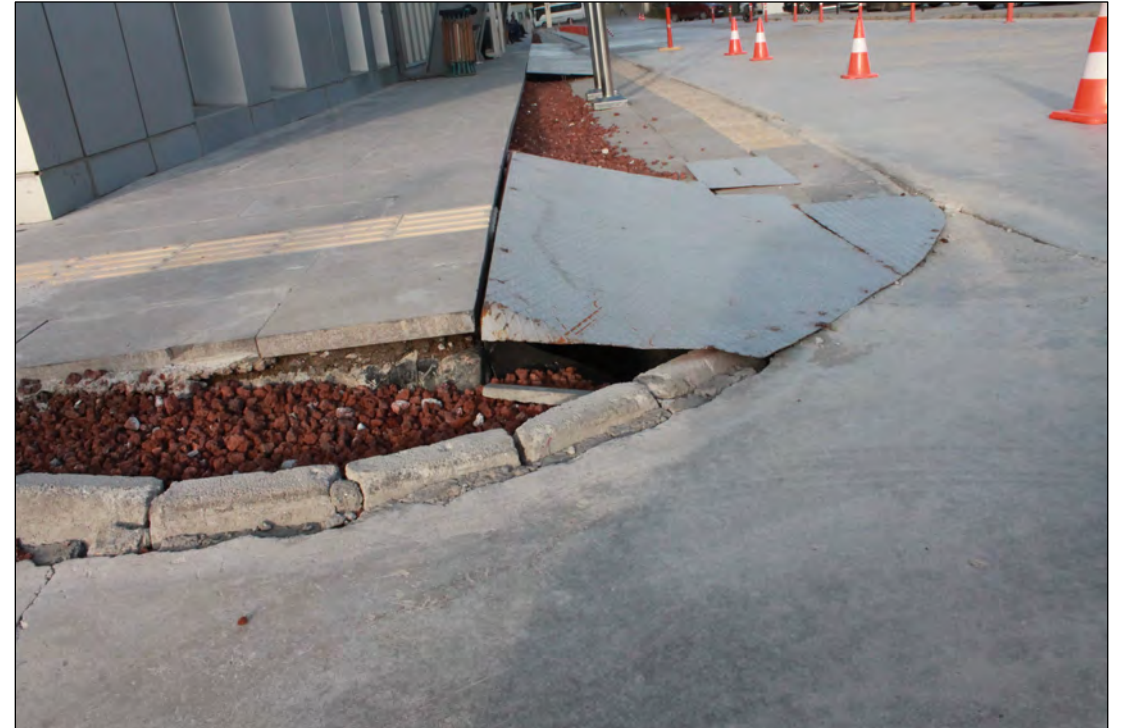
Base-Isolated Hospital: Malatya

Pumice-like material was used in the moat (crushable material)

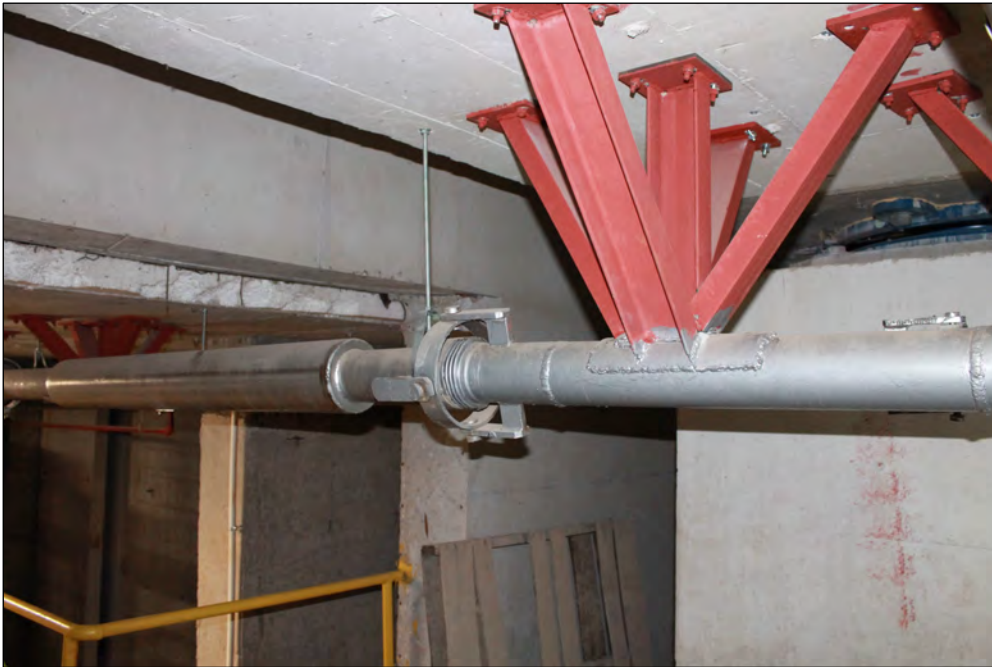
Base-Isolated Hospital: Osmaniye

Flexible connections between at the interface between the isolated and superstructure and fixed substructure

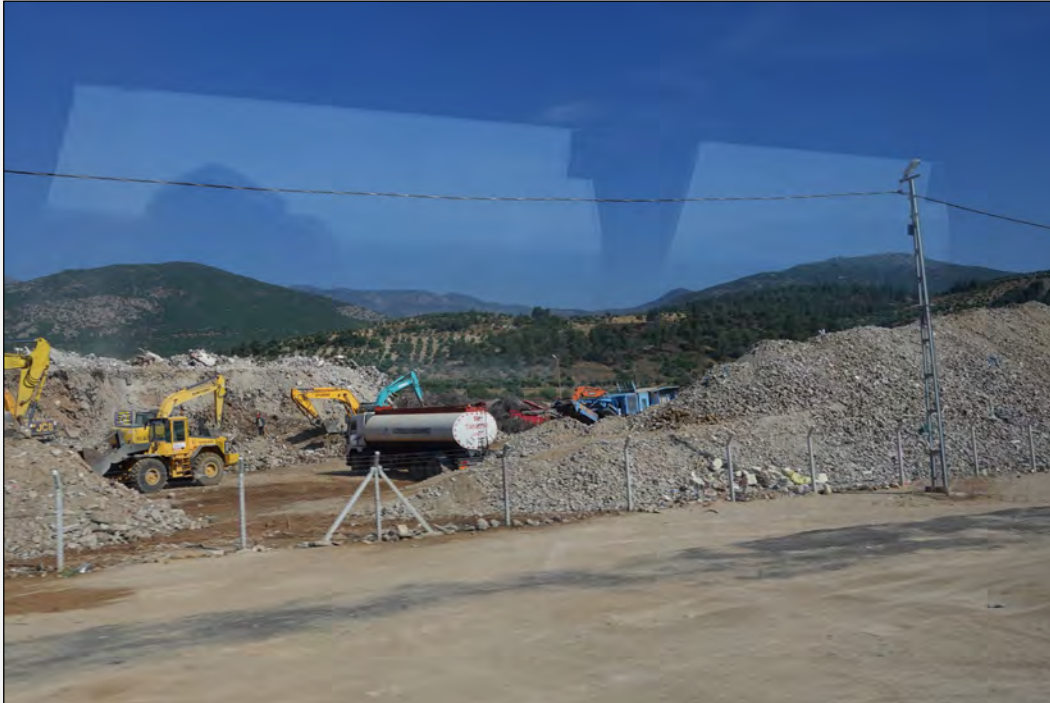
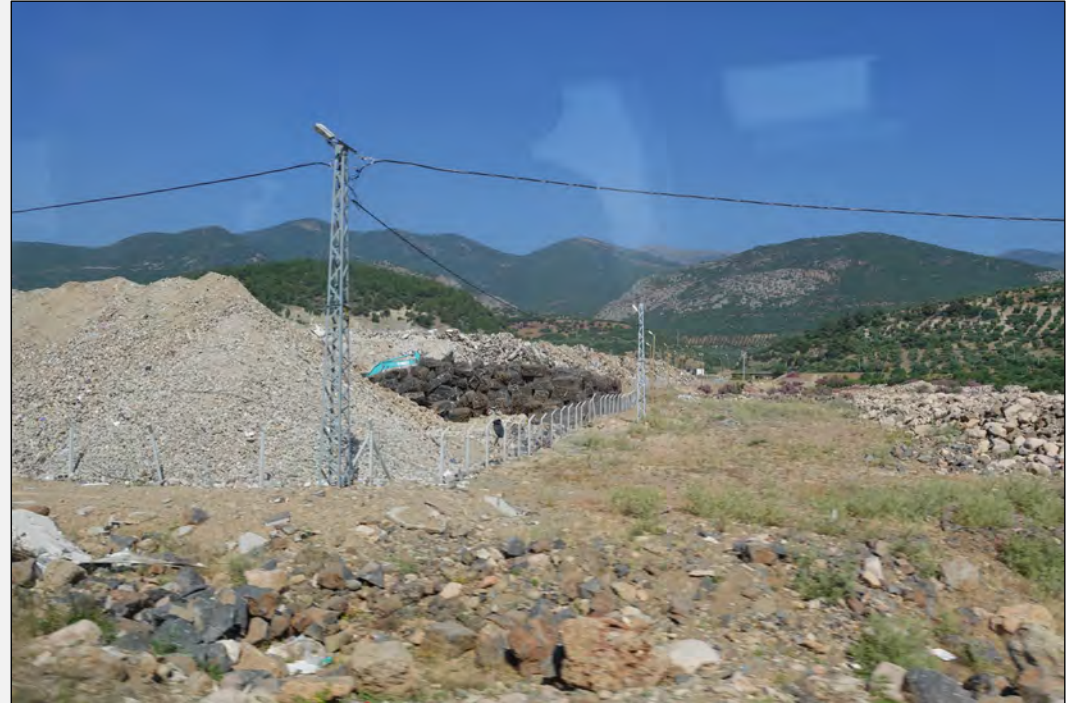
Debris clean-up started on a large-scale February 23, 2023

- Material separated to be recycled

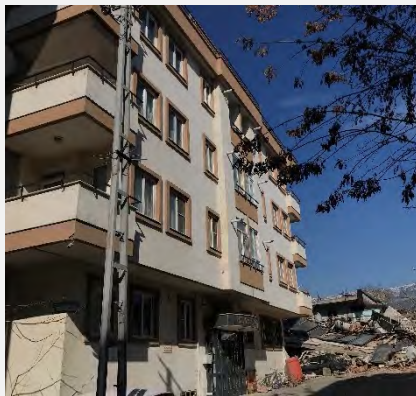
Dulkadiroğulları, Kahramanmaraş

Undamaged Building

No earthquake damage

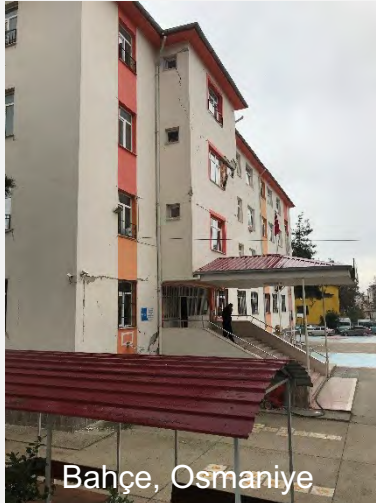
Bahçe, Osmaniye

Slightly Damaged Building

Minor damages

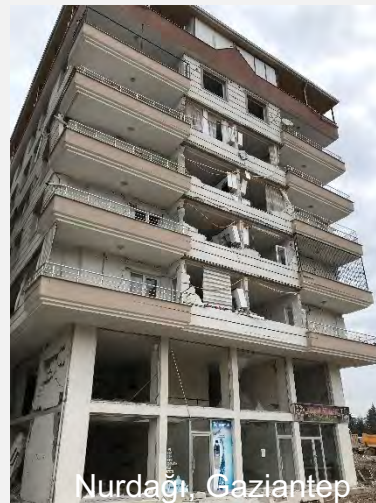
Nurdagi, Gaziantep

Moderately Damaged Building

Certain decrease in the capacity

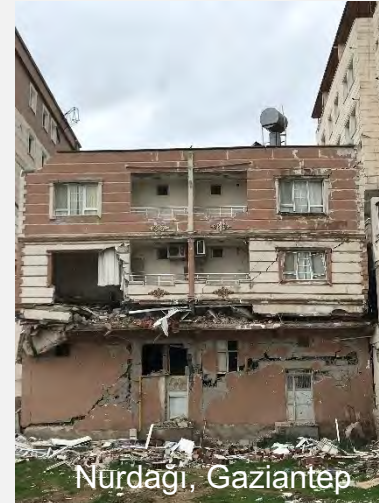
Nurdagi, Gaziantep

Heavily Damaged Building

Significant lost of pre-earthquake performance

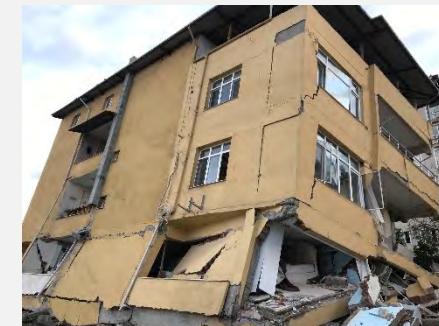
Kırıkhan, Hatay

Building to be Urgently Demolished

partial collapse, residual displacements

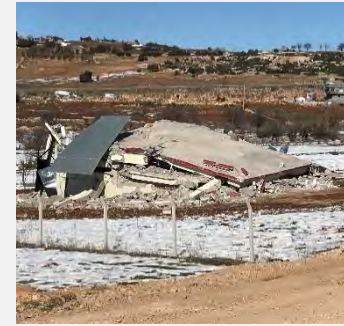
Kömürler, Gaziantep

Collapsed Building

Complete collapse

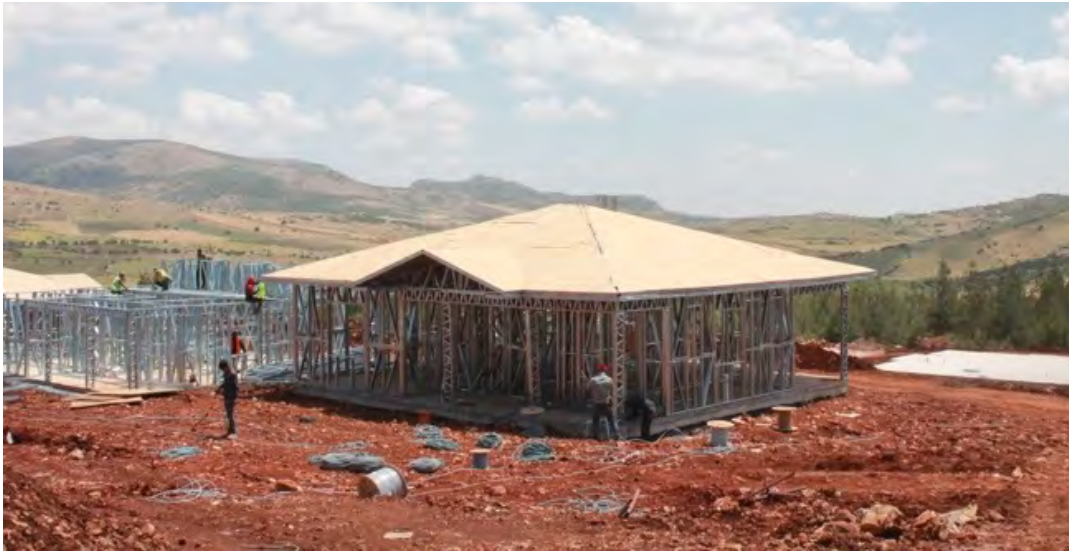
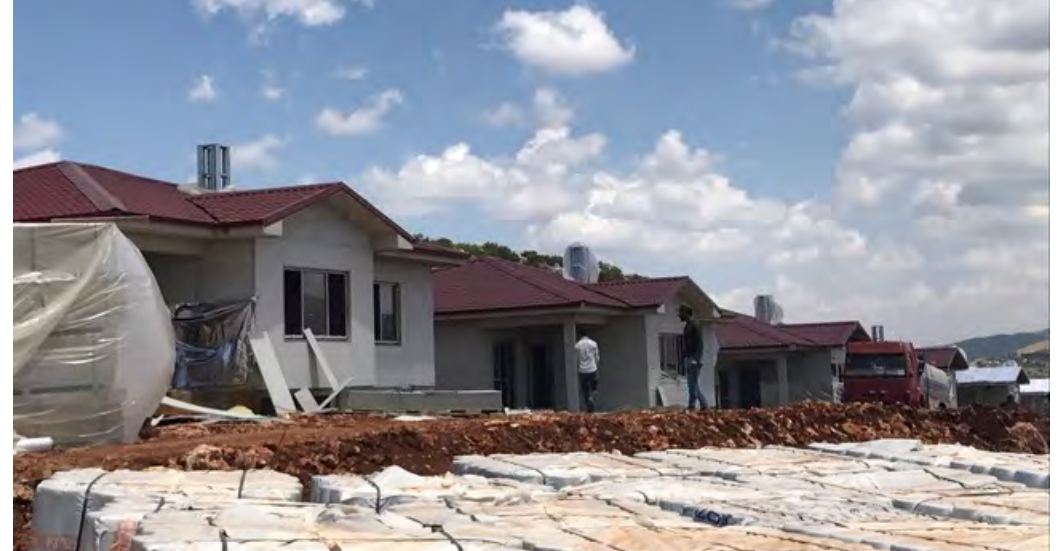
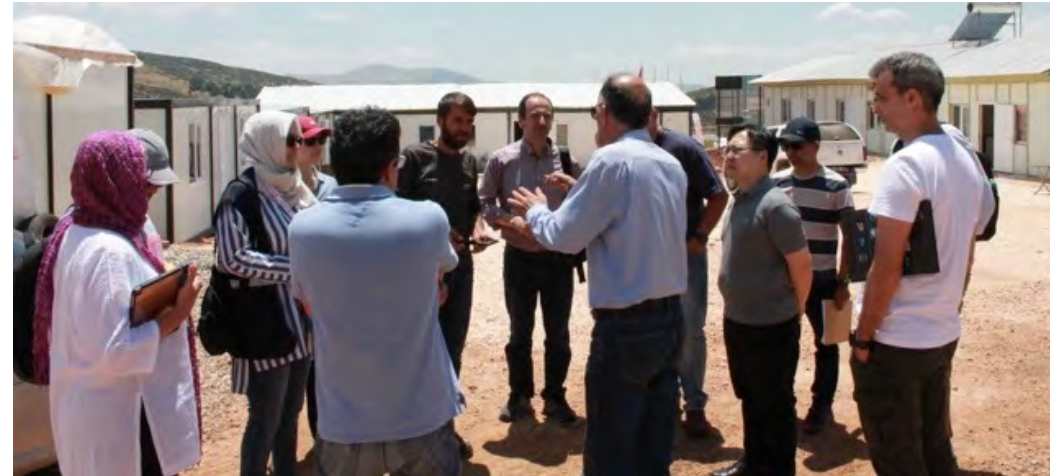
Reconstruction sites:

- The newly constructed village. 400 units, each 1280 sf (3 rooms, 1 living room and a kitchen).
- Cost of one house is ~100,000 USD, and each family will pay 40,000 USD (24 years mortgage) with the remaining amount covered by the government.
- Cold-formed steel fabricated.
- Each house is completed in 20 days with 50 workers.
- Began on March 10, 2023, and it is planned to be completed in 9 months.
